## **OPTIMIZATION OF HYDRO POWER PLANTS PERFORMANCE IMPORTANCE OF REHABILITATION AND MAINTENANCE IN PARTICULAR FOR THE RUNNER PROFILES**

### ***ABSTRACT***

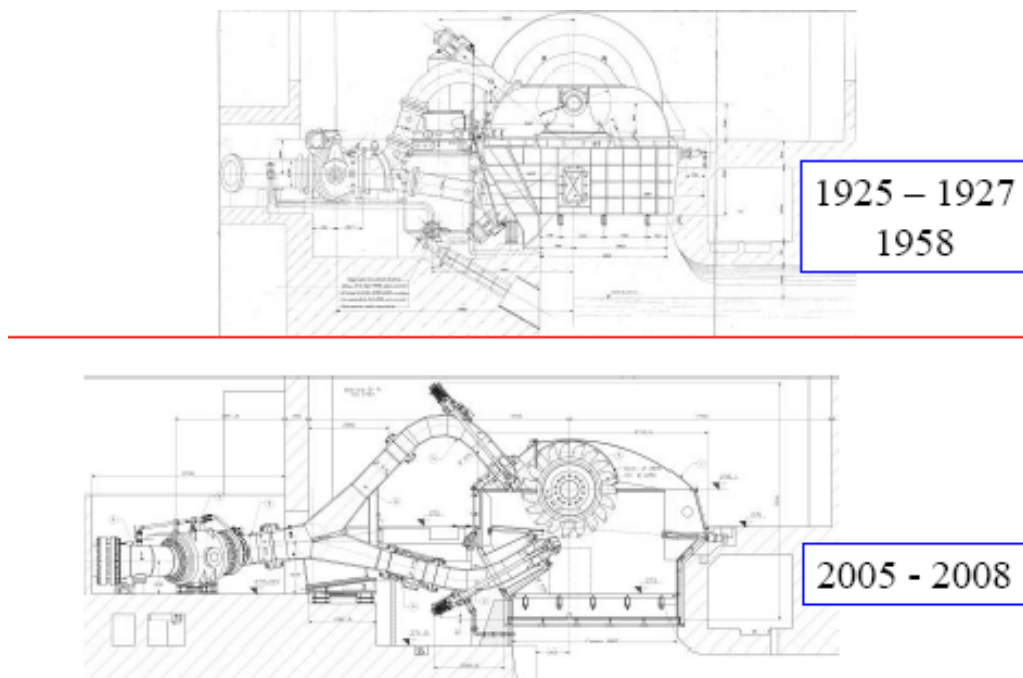
Fig.4a Pelton partial renewal: old and new design

The partial renewal of 5 horizontal double nozzles Pelton groups, keeping the existing penstock, housing and foundation, made possible a power and efficiency increase (see Fig. 4a&b). Efficiency Test on the Power plant has been made by thermodynamic method foreseen by the IEC code.

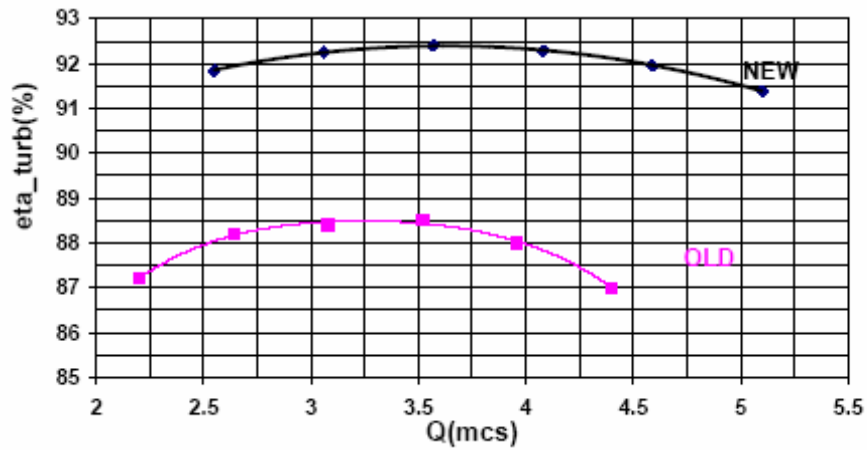
Fig.4b Pelton partial renewal: comparison of guaranteed efficiencies

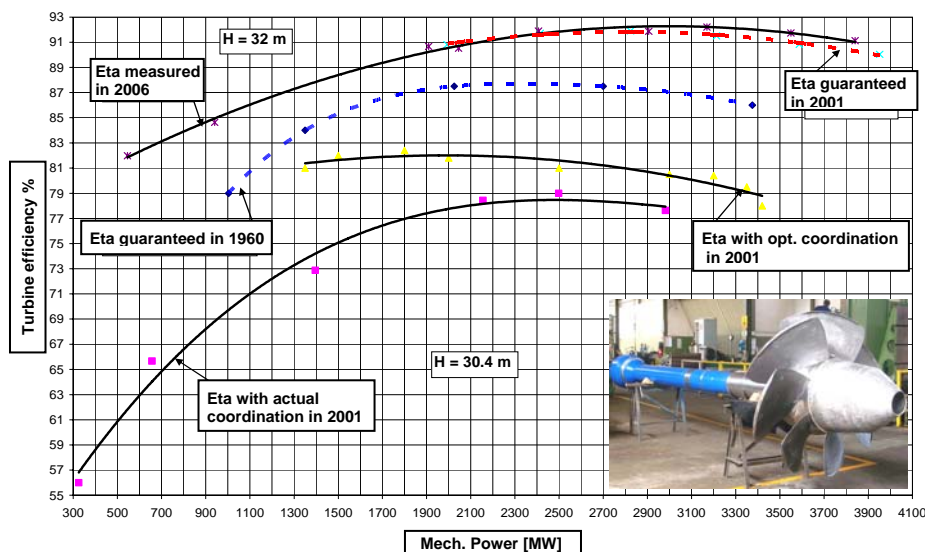
Fig 6 Partial renewal of Kaplan group

An example of performance improvement thanks to partial renewal of a vertical Kaplan group, with new runner and distributor, while the embedded parts are left unchanged, is reported in Fig .6.

The measured performances, before and after the intervention, are here compared.

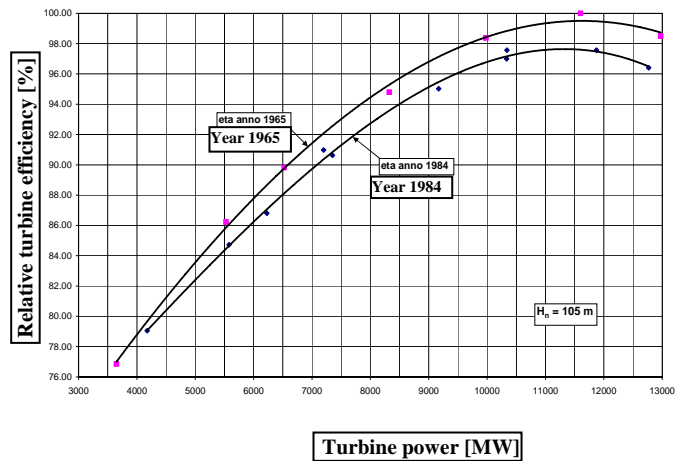
Fig.12 – Decay of efficiency produced by wear

At side is reported an example of performance decay, measured on horizontal 13 MW Francis turbine after 20 years of operation.

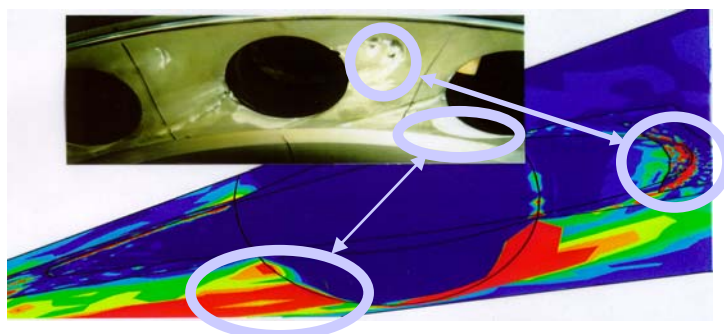
Fig.14 - Numerical simulation of the flow distortion caused by the increase of clearance between wicket gates and wearing plates and effects of concentrated erosion on the runner (dx).

The gap increase between wicket gate and wearing plates produces an increase of volumetric losses and vortices, thus disturbing the flow at the outlet of the distributor and therefore causing decay of the energy transformation in the runner and efficiency loss.

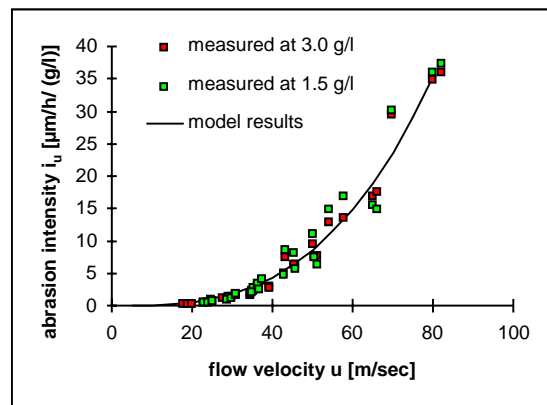
Fig 17 Abrasion rate versus flow velocity

Actually, it has been experienced that, with increasing of the surface roughness, the wear phenomenon tends to accelerate, due to increase of flow turbulence in the boundary layers in contact with the wet surface (see diagram Fig 17).

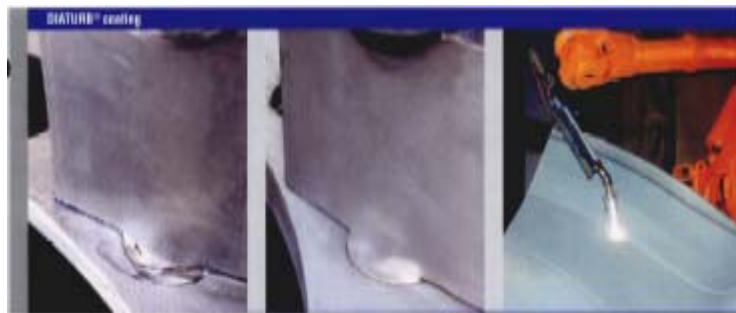
Fig 20 Coating on Francis components

We draw the attention to the fact that, for the quality of the coating and therefore for its efficacy and time duration, it is very important to respect the constant parameters of application, e.g. thickness, angle and velocity of application.
