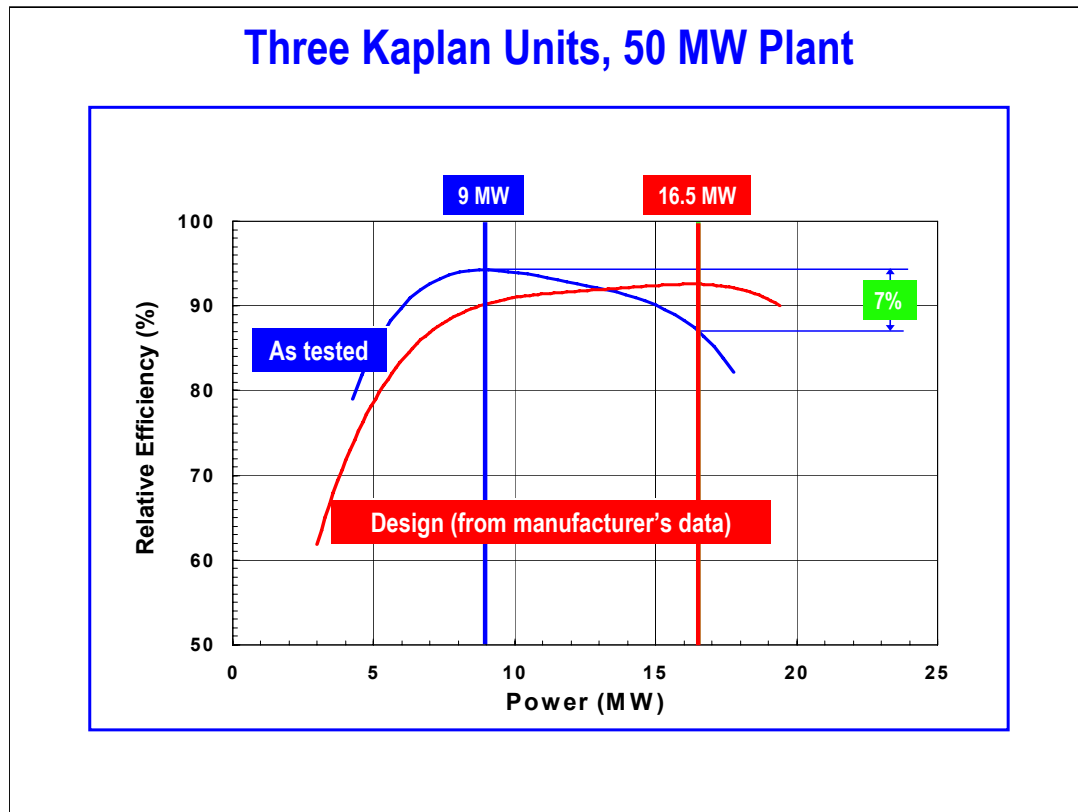
The slide provides an example for the importance of using accurate performance information. The utility used incorrect performance information from the manufacturer (**red curve**), which led to thirty-five years of inefficient operation at 16.5 MW (**green line**). At this load, the units were operating about seven percent below the best efficiency, with resulting losses worth more than \$11,000,000 over the thirty-five year period. Without the benefit of the updated performance characteristics (**blue curve**), the plant's maintenance supervisor had tried for years, unsuccessfully, to convince the utility's management that the units should be operated at the low vibration "sweet spot" between eight and nine MW.
